TECHNICAL REPORT

Cleanup of Johnston Atoll missile launch facility

AFRRI TR88-1

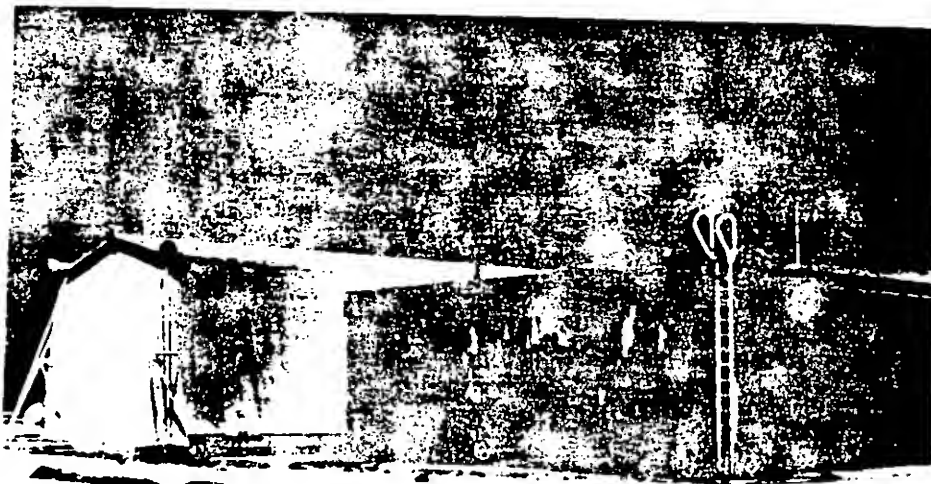
Figure 3. Missile shelter building (background) and steel blast revetments (foreground)

On either side of the moveable missile shelter were revetments constructed of steel piling and thick steel roof plate covered with asphaltic material. The interior and exterior walls were about 4 feet apart, and the space between was filled with aggregate coral. These revetments stored control and diagnostic missile equipment and protected vehicular trailers (which also stored missile equipment) from the blast and heat of the missile launches. Situated near the revetments about 5 feet below grade were the large fuel tank and liquid oxygen tank (Figure 4). The tanks were mounted on concrete pads surrounded by embankments constructed of loose gunite concrete. Also on the site were four 28,000-gallon water tanks (installed after the launch failure); several small concrete pads; and arrays of cable trenches, conduits, metal piping, and electrical cables.

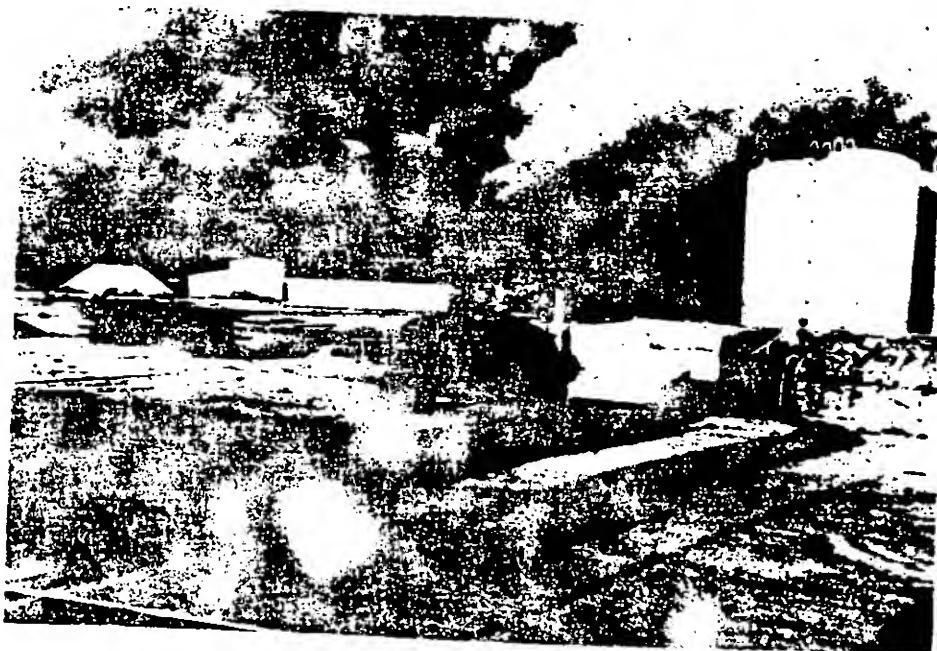
Figure 4. Below-grade liquid oxygen tanks and 28,000-gallon water tanks

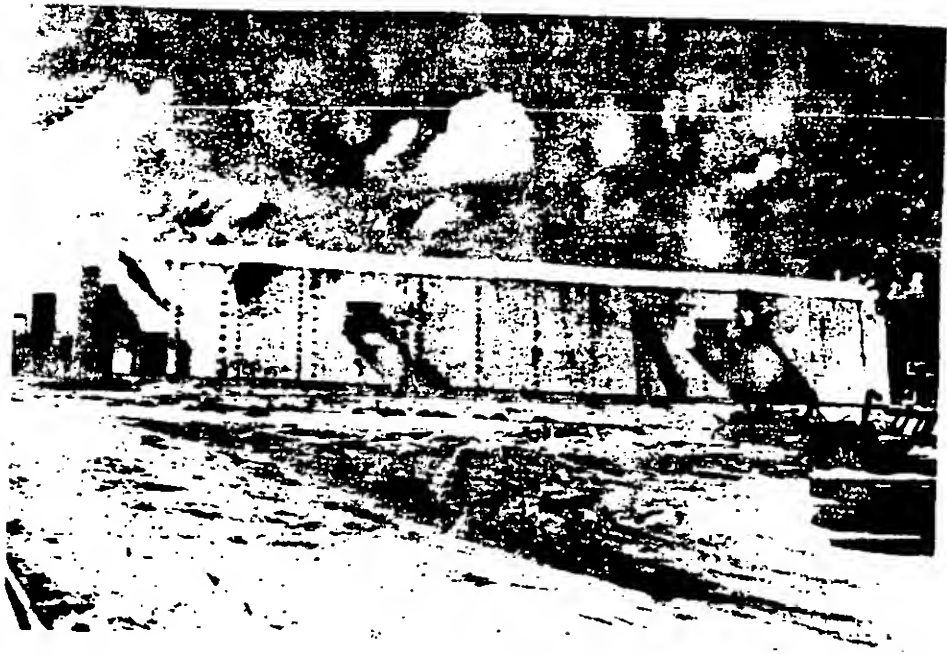
Figure 6. Missile shelter building before disassembly

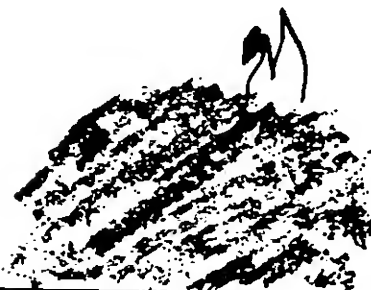
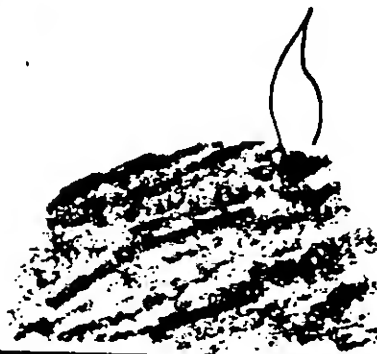
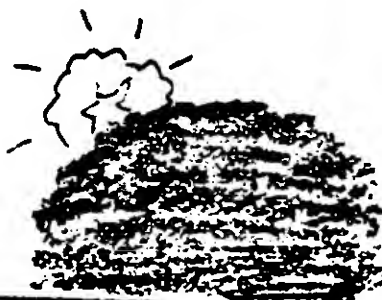
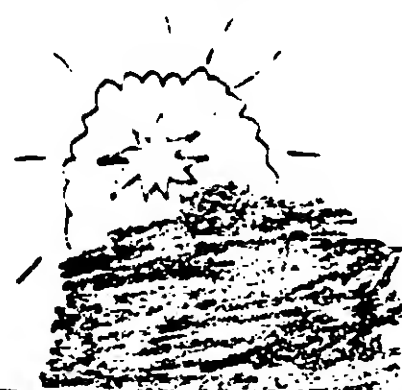
CAMERA GROUND LEVEL VIDEO TAPE SEQUENCE

T+0 SEC
DIFFUSION FIRE

2000' EAST OF SILO
(OBSTRUCTION BY 30' TREE)

T+3 SEC
JETTING FIRE

T+4 SEC
SMALL EXPLOSION

T+4.5 SEC
SECOND LARGE EXPLOSION

T+4.6 SEC FIREBALL
